# St James' Church, Wick

## **Structural Appraisal of Tower – Update to 2006 Report**

## **Rectorial Benefice of the Glamorgan Heritage Coast PCC**

Date: Feb 2020

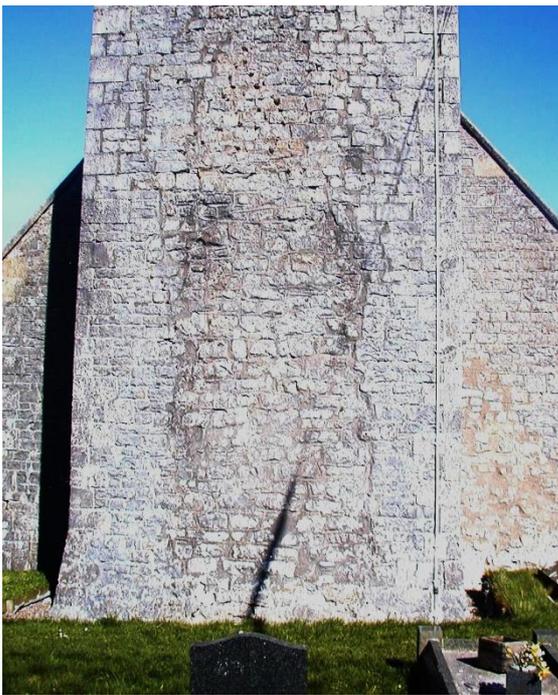
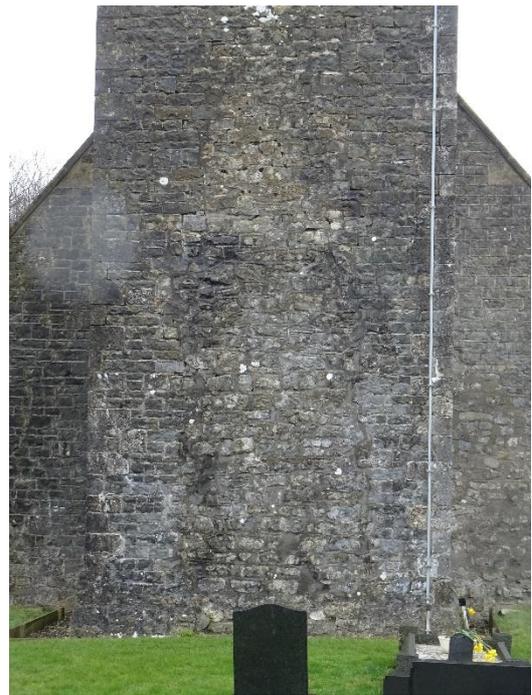
- 2.1.1 From a visual inspection from ground level, there is little evidence of any deterioration of the masonry of the tower since 2006. There are no obvious new cracks or widening or lengthening of existing ones.
- 2.1.2 The most significant defects identified in 2006 were as follows:
- 2.1.3 West elevation – apparently rebuilt masonry with bulging section. There is no obvious sign of change here. See comparative images below.

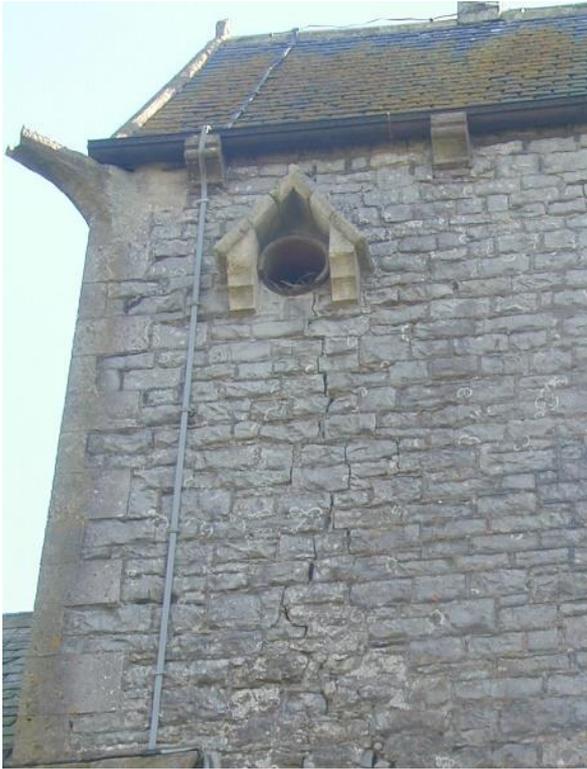
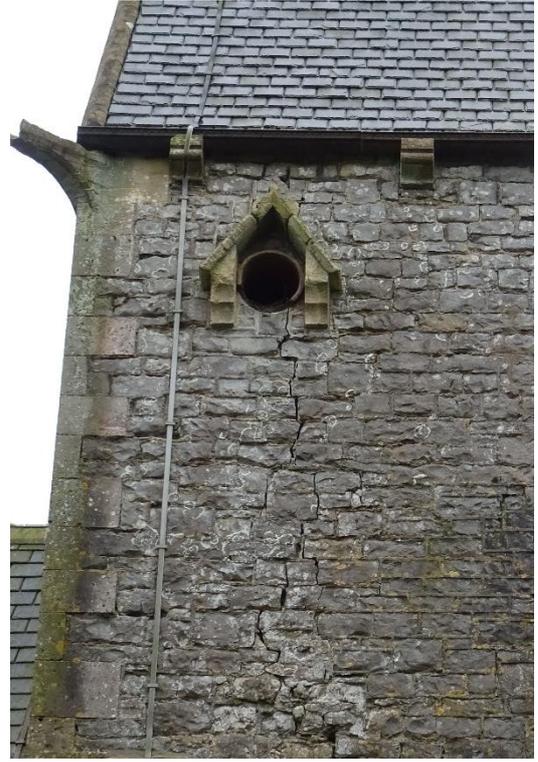
2.1.4 North elevation – significant vertical crack at high level – no discernible change to severity or extent

- 3.2.1 The vertical crack at high level on the north wall remains the most significant defect, and the one with most scope for allowing water ingress and associated deterioration.

- 3.2.2 We therefore recommend that the wall is scaffolded, mortar joints raked out and stainless steel Helibar reinforcement inserted into the joints, which can then be made good. The cracks should also be made good by filling with lime mortar. This is a simple and cost-effective technique which should reduce the risk of cracks worsening here.

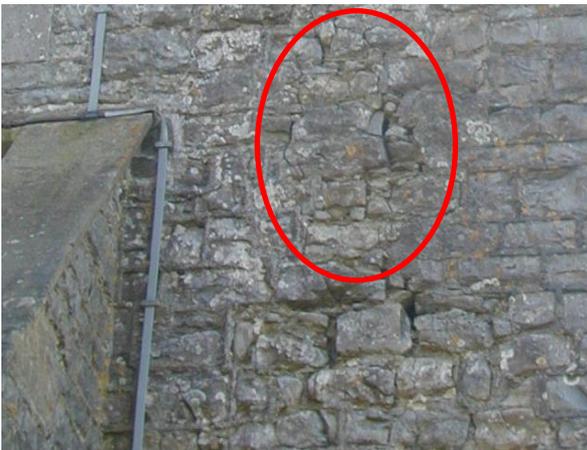
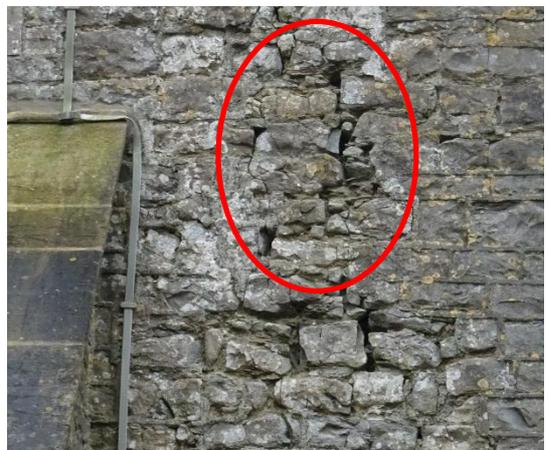
2.1.5 North elevation – degraded facing masonry – there is local evidence that this has worsened somewhat, with some loss of small facing stones leaving voids, and further fracturing of some of the larger facing stones. The deterioration is not severe, but it is present.

- 3.2.3 On the same wall, the section where the facing stone is badly degraded should be made good, by piecing in new stone and/or locally consolidating as required.

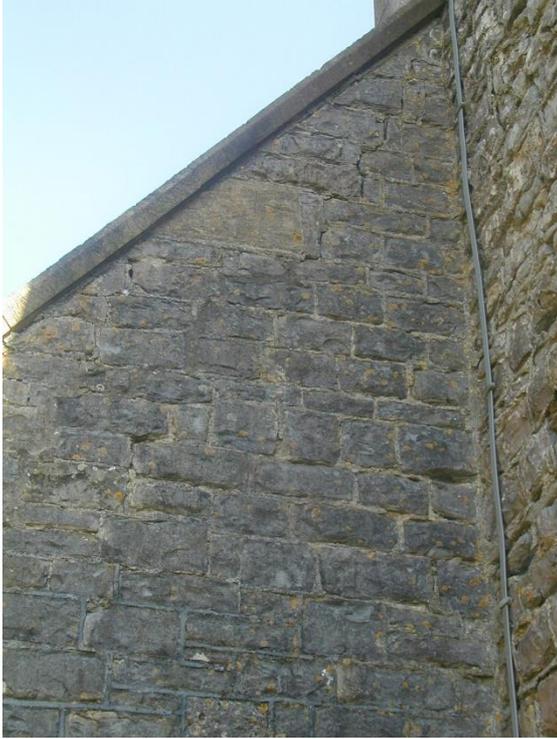
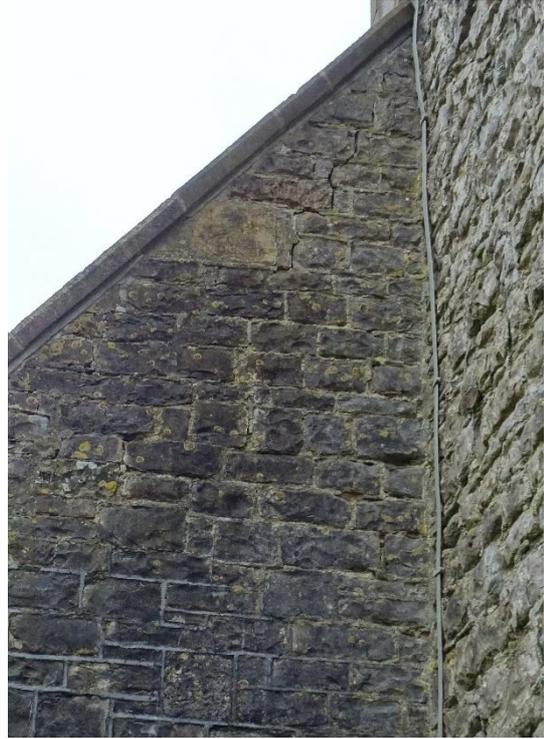
2.1.6 Cracks to north aisle return wall – there is no change detectable here. The copings to the wall head have either been re-set or pointed in as part of the recent roof replacement works.

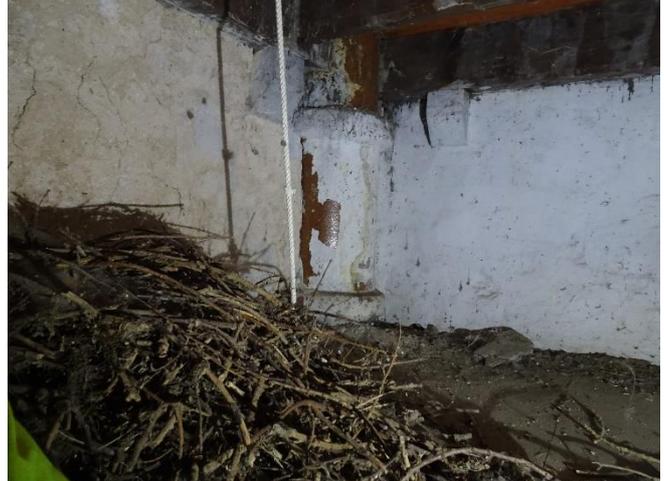
2.2.1 Access to the tower internally was limited. Ladder access allowed the hatch through the ceiling to be opened, but the hatch above through the first floor was entirely blocked with bird nesting materials. There is a considerable build up of this material on the ceiling.

- 3.2.4 Internally, we recommend removal of the bird nesting material in the tower. If left in situ, it prevents access to inspect the rest of the tower, and the damp material piled on the ceiling will accelerate its decay. Once better access is available, the integrity of the first-floor structure should be checked, and if necessary steps taken to renew decayed elements. If left in its current condition, the decay present is progressive, and will lead to collapse of the floor structure, putting ground floor users at risk.

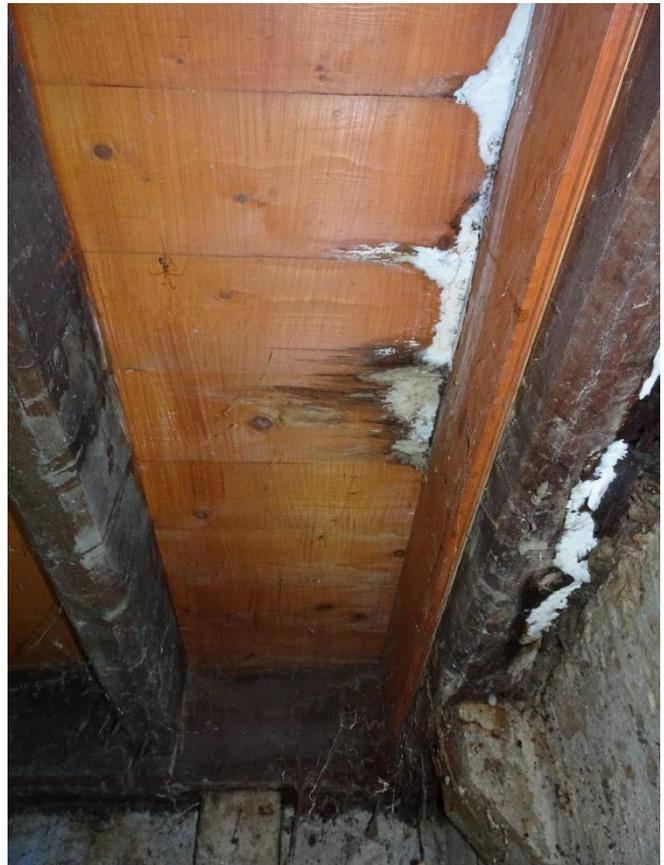
2.2.2 There is quite significant fungal decay to the timber next to the wall supporting the first floor, and to the floorboards adjacent to the wall.

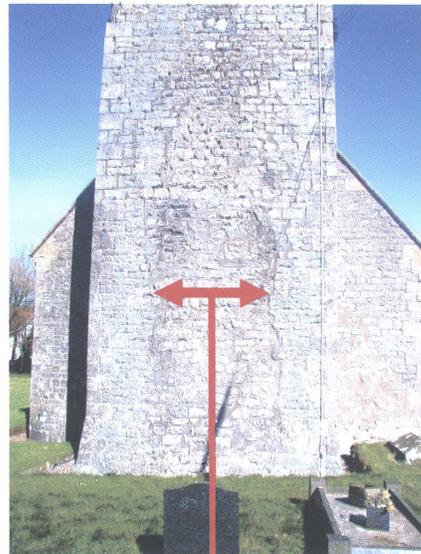
Apparently rebuilt masonry

- 2.2.4 The rubble masonry of the tower has been much altered. On all three principal faces (south, west and north) large areas up to approximately the mid-height of the tower appear to have been rebuilt. The rebuilt portions appear to comprise much of the three sides of the tower excluding the south west and north east corners. The entire tower, and the remainder of the church, has been pointed at various times with hard cement mortars. Some of the rebuilt sections of the tower are poorly constructed, particularly on the west face where the masonry bulges out by approximately 100mm relative to the remainder of the tower in a zone approximately 3m to 6m above ground level.

- 4.2.1 The junctions of the apparently rebuilt areas of stonework with the apparently older sections should be locally investigated by the removal of stones at the junction to attempt to determine the likely history of the alterations and if possible the condition of the rubble core of the wall.
- 4.2.2 Access should be provided inside the tower to allow the area of wall corresponding with the crack externally on the north face to be inspected.
- 4.2.3 Dependant on the outcome of these investigations, it is anticipated that "grouted sock" anchors will be used to tie across the junctions between the rebuilt and original areas of stonework and across the crack on the north face.
- 4.2.4 Consolidation grouting of the wall core and local masonry repairs, especially on the north face, should also be carried out where required.

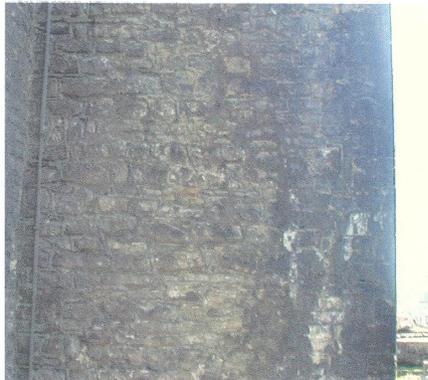
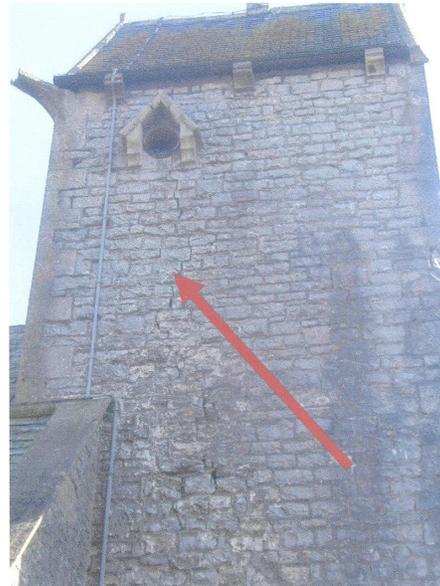
- 2.2.5 On the north face the area of rebuilt masonry has deteriorated significantly, losing the facing to the rubble stonework over an area of several square metres. At high level on this face there is a near vertical crack. The crack tapers from approximately 100mm near eaves level to zero at the top of the rebuilt section, a distance of around 4metres.

- 3.1.3 The hard cement pointing is detrimental to the facing stonework, trapping water in the mortar joints behind the pointing and leading to potential damage due to freeze – thaw action. The effects of this are visible on the north face of the tower where a substantial area of facings to the stonework has fallen away.

- 3.1.4 The cause of the crack at high level on the north face is not apparent, and its severity is not clear as it may penetrate through the full wall thickness and be concealed by the heating flue on the interior. It seems unlikely that the flue or its fixings are the cause of the cracking but closer inspection at high level should reveal more here.

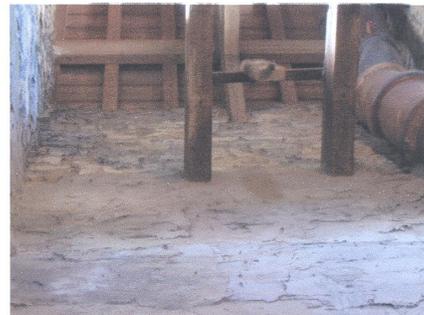
- 2.2.6 Internally, the tower is plastered up to the "first floor level" (approximately 3m above ground level). Above this the walls have been rendered with a rough cement render up to the point at which they reduce in thickness. The crack in the north wall is not visible internally although it may be concealed behind the heating flue.

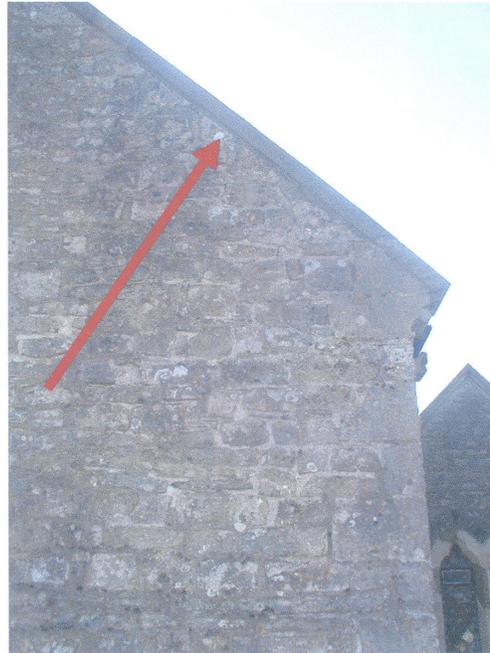
2.3.1 There are a number of cracks visible externally in the stonework on the corners of the nave and chancel. The crack patterns on the north west, north east and south east corners of the church are similar.

- 4.3.1 The coping stones should be locally removed from the north and south gables to investigate the presence of corroding ferrous clamps which may be causing the cracking in these areas. Although no cracking was noted to the masonry of the south west corner, it would be prudent to investigate the fixings of the copings here when the works are carried out to the other three corners.
- 4.3.2 Repairs of the cracked areas incorporating "grouted sock" anchors should be carried out and the copings replaced using non-ferrous clamps.

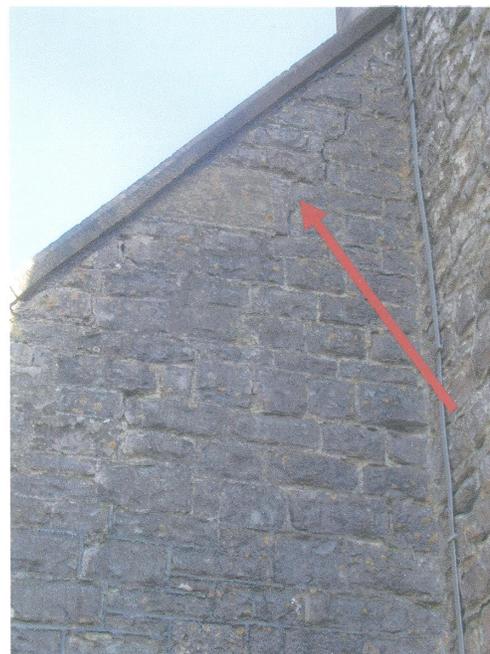
2.3.2 Diagonal cracking occurs on the gable walls roughly following the slope of the top of the gable, in some cases immediately below the dressed stone copings and in some cases a few courses lower down. The cracks extend on the western gable from the abutment of the nave roof with the tower almost to ground level. The cracks measure up to 5 -10mm wide locally at high level on the western gable but more typically 1 - 2mm lower down. In a number of locations the cracks are through stones, not through the mortar joints. The cracks are less extensive and less severe on the east gable.

- 3.2.1 The diagonal cracking following the line of the gable copings is likely to be related to water ingress at the tops of the walls. The copings may have been periodically renewed as they are more exposed to the weather than the remainder of the walls. If not properly bedded on the wall below they are prone to movement down the slope of the gable. Water ingress may also have affected ferrous fixings of the copings causing corrosion and damage to the masonry. The tops of the walls are also more exposed to thermal changes and less restrained by their mass than the body of the walls below.

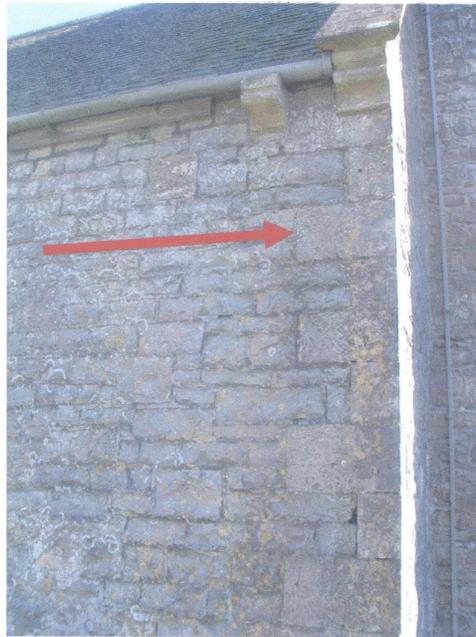
- 2.3.3 Near vertical cracks are also present on the north wall adjacent the north west and north east corners. They roughly follow the joints around the dressed stone quoins although there are occasional cracks through stones. Typically the cracks are 1-2mm wide.
