St James' Church, Wick is a Grade II* listed building. As a consequence of this designation it is statutorily protected. Extreme care should therefore be taken not to cause any unspecified damage to any fabric or part of these structures on or within the site when undertaking any construction works.

Upon the chancel of St James' Church set against the east wall beneath a Laudian window stands a pre-Reformation altar slab incised with a central consecration cross, dressed from local limestone. The altar slab or mensa of pre C16 origin is of great importance within the Parish.

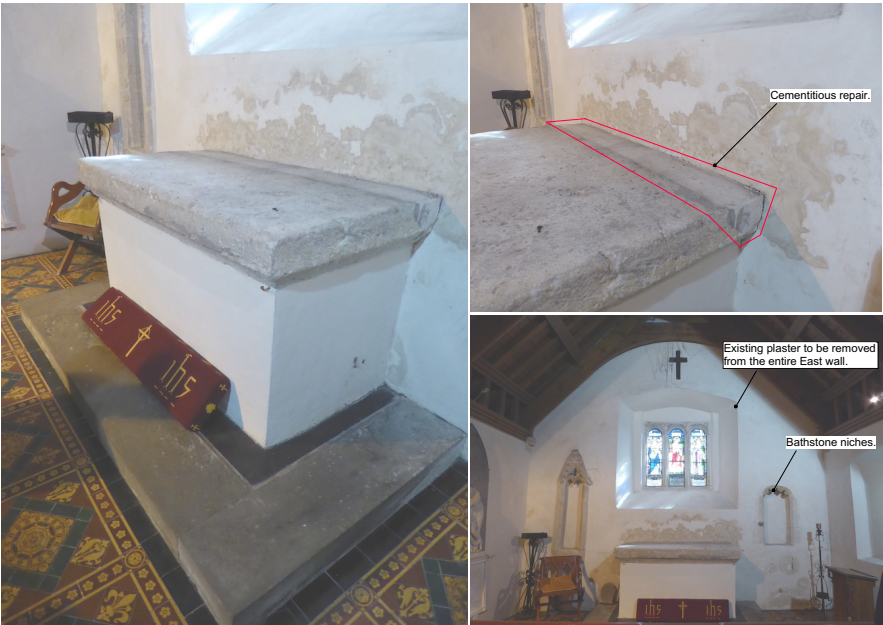
PHOTOGRAPHS OF EXISTING ALTAR

- 2. EAST WALL:
The east wall of the church has signs of water ingress which has damaged the plasterwork. The relocation of the altar will allow remedial works to address the water ingress. The existing plaster is damaged in small isolated locations and will also be scared when the altar is moved. It is anticipated that the dampness will largely be cured following repointing of the walls externally. Minor patch repairs using lime mortar will be undertaken and painted with mineral based paint.

The black ledger stone beneath the altar is currently mainly obscured by the altar's plinth. It is believed to be from the 18th century. When the alter table is dismantled the memorial will be recorded before the new altar plinth is erected. The new design will expose far more of the ledger stone that can be seen currently.

- 1. REPAIR OF STONE ALTAR:
The existing stone altar slab is to be removed from its existing plinth, carefully breaking away the cementitious repair without damaging the natural stone. The slab is then to be repaired by a specialist conservator/ stone mason, using a length of stone to piece in the missing edge and dressed to the (presumed) original form. A local limestone is to be used during repairs.
- 2. NEW STONE WALLS
New ashlar stone walls are to be introduced to replace the existing plinth, set up to the front of the altar step.
