# St James' Church, Wick

## **Structural Appraisal of Tower – Update to 2006 Report**

## **Rectorial Benefice of the Glamorgan Heritage Coast PCC**

Date: Feb 2020

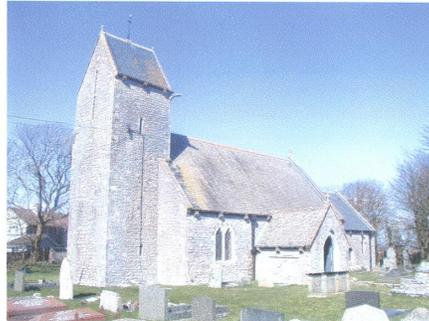
- 2.1.1 The structure is predominately of medieval origin, believed to date from the fifteenth century. The nave is reported to have been rebuilt by John Prichard in 1871. The building comprises a traditional church plan from east to west of chancel, nave, and tower with a porch to the south.

- 2.1.2 The principal structure comprises load-bearing random rubble stone walls with timber roof structures and slate roof finishes.

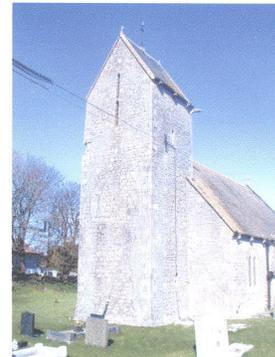
- 2.2.1 The west tower measures approximately 3.6m square on plan and is approximately 10m high to the eaves. It has a steeply pitched roof with the ridge oriented east-west. The walls are around 900mm thick at the base reducing to approximately 600mm thick around 6m above ground level.

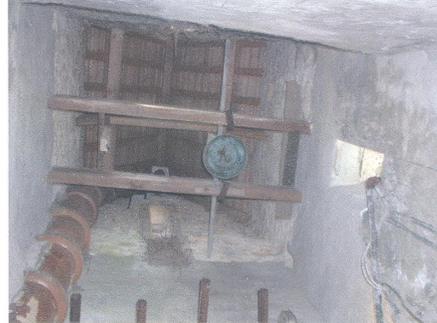
- 2.2.3 Internally there are two levels: ground floor level and a timber joisted first floor. The first floor boards are rotten and unsafe. A single small bell is suspended at high level above the slit windows. There is a disused vitrified clay heating flue in the north east corner of the tower. The flue is around 400mm in diameter up to eaves level. Above this level the diameter reduces and the flue appears to exit through the ridge adjacent to the east wall.

- 3.2.4 Internally, we recommend removal of the bird nesting material in the tower. If left in situ, it prevents access to inspect the rest of the tower, and the damp material piled on the ceiling will accelerate its decay. Once better access is available, the integrity of the first-floor structure should be checked, and if necessary steps taken to renew decayed elements. If left in its current condition, the decay present is progressive, and will lead to collapse of the floor structure, putting ground floor users at risk.
